Inspection Report

Property Address:
31144 S Joe Street
Salt Lake City UT 8410

Elite Property Inspection LLC

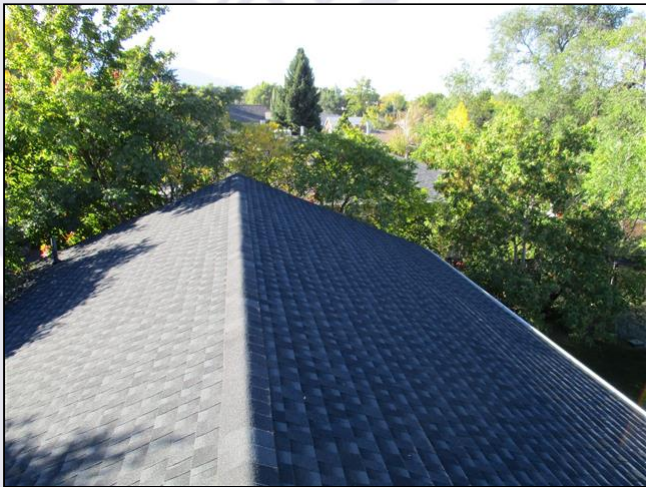
1.0 Item 1(Picture) Roof

-Roof appears to be in good condition.

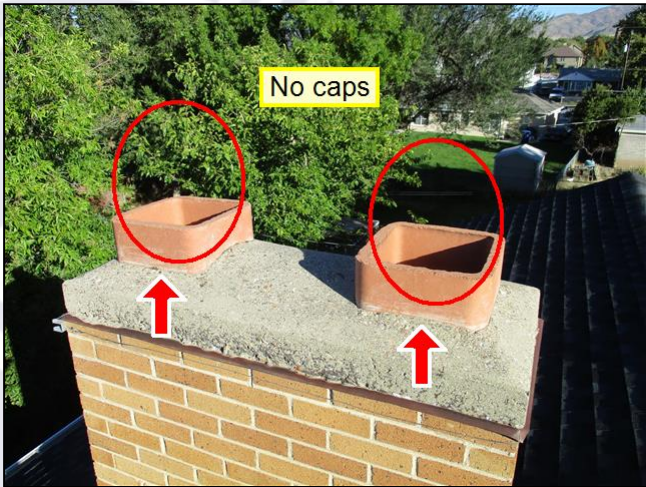
1.2 Item 1(Picture) Chimney roof caps

🔧 (1) -No caps on top of chimney. -Recommend installing caps to prevent water and animals from accessing area.

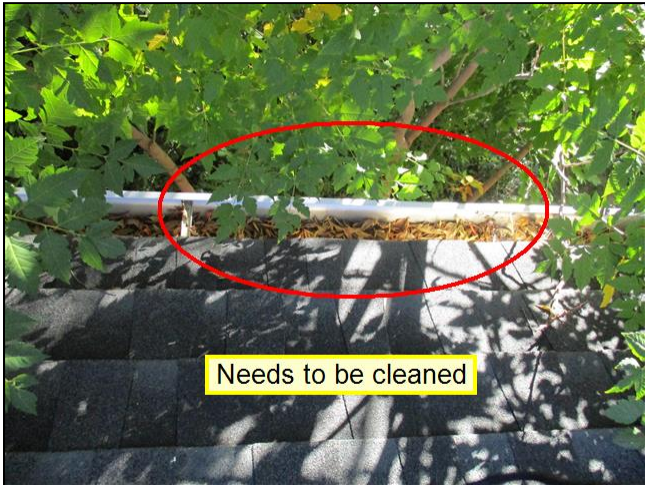
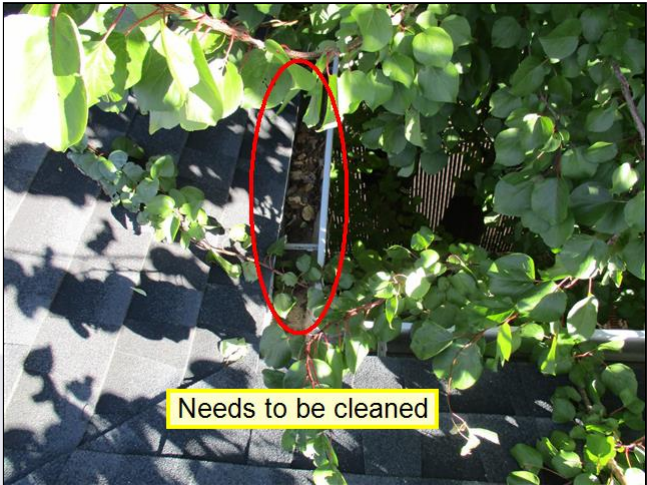
1.4 Item 1(Picture) Gutters

-Gutters are full of debris in areas and needs to be cleaned. The debris in gutters can also conceal rust, deterioration or leaks that are not visible until cleaned, and I am unable to determine if such conditions exist.
-Recommend adding kickout to all downspouts.

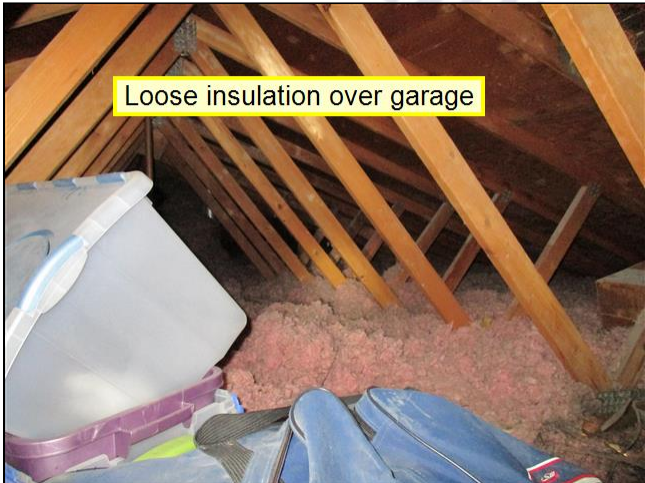
1.6 Item 1(Picture) Insulation over garage

-Insulation in attic over the garage was seen, most of insulation was over living area (camera facing west over living area). Unable to identify insulation over other area due to granite counter top and oven obstructing area. These items can be very easily damaged.

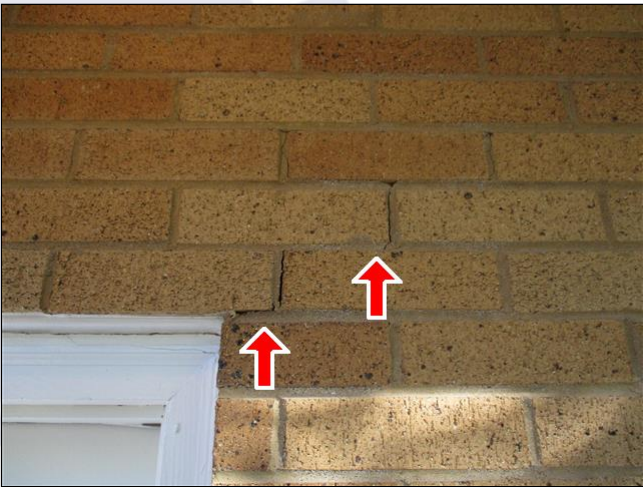
2.0 Item 1(Picture) Exterior

-Small crack on exterior of home.
- Recommend monitoring cracks for expansion and growth.

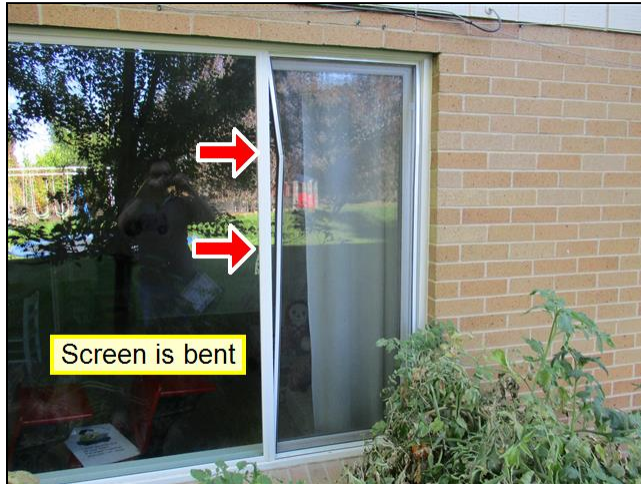
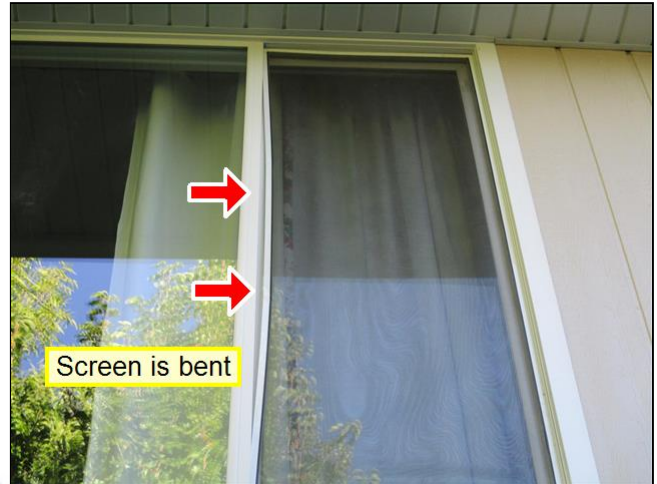
2.2 Item 1(Picture) Lower level window

- 🔧 -Screens are bent on northwest corner of home upper and lower level window.
-Recommend straightening or replacing. Screens help to prevent insects from entering home.

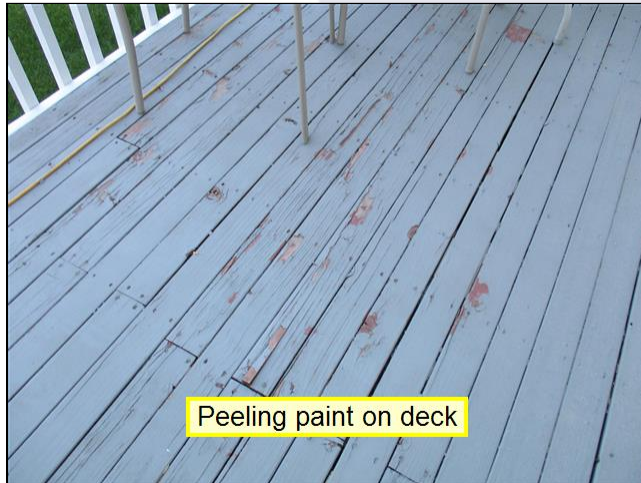
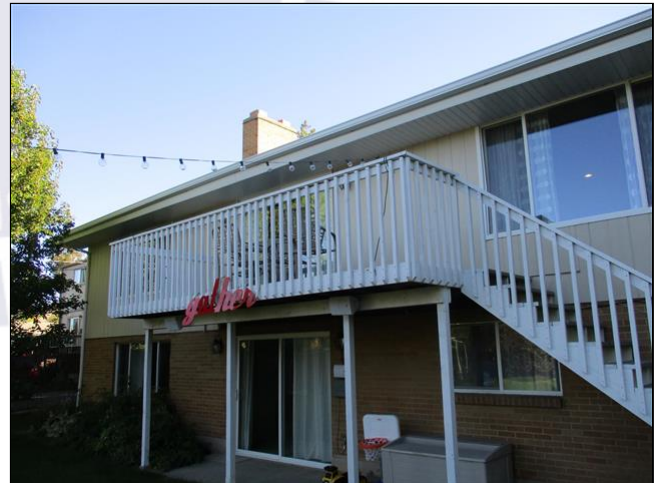
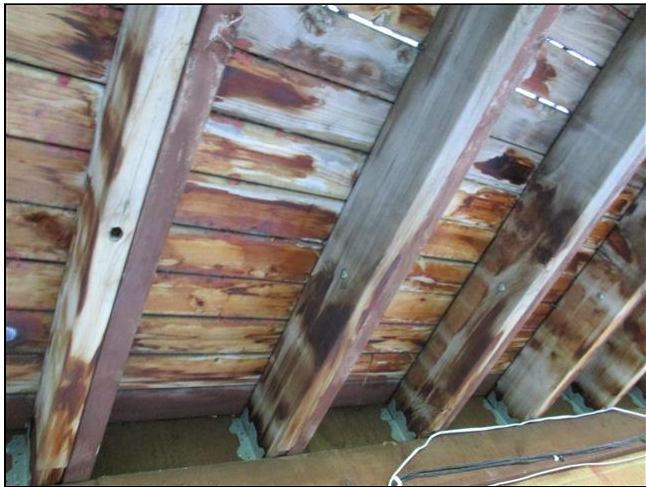
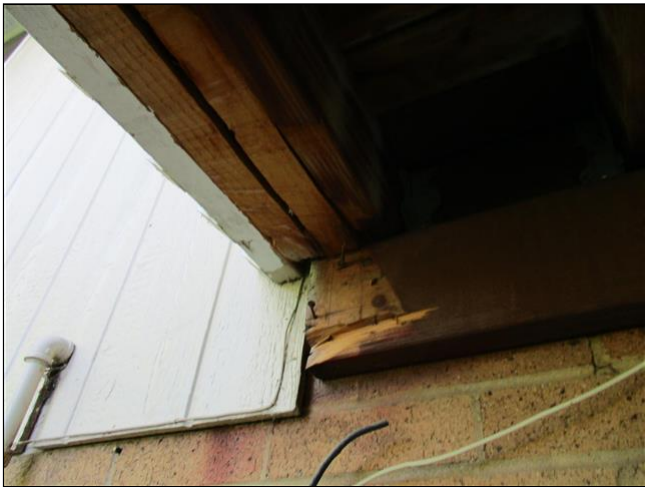
2.3 Item 1(Picture) Deck

- 🔧 (1) -Deck has peeling paint.
-Railing appeared to be in good condition at time of inspection.
-Deck looks like it is attached to the home with wood nails and hangers, unable to see any lag screws attaching it to home.
-Deck does not appear to move when walked on.
-Recommend having a licensed contractor look at deck to verify if it is structurally sound.
-Recommend cleaning deck and sanding and painting as needed.

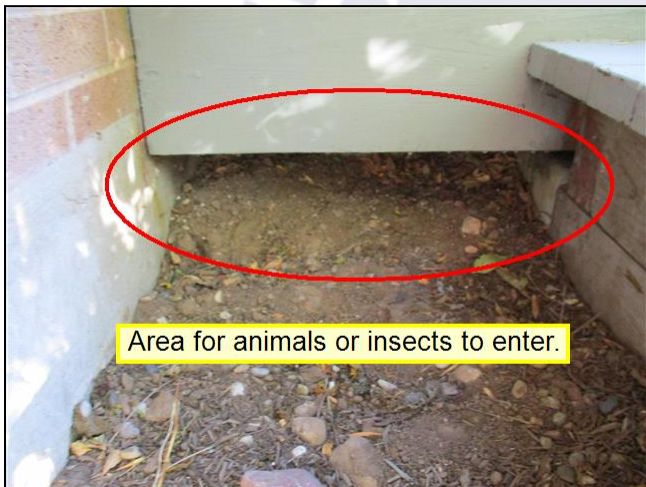
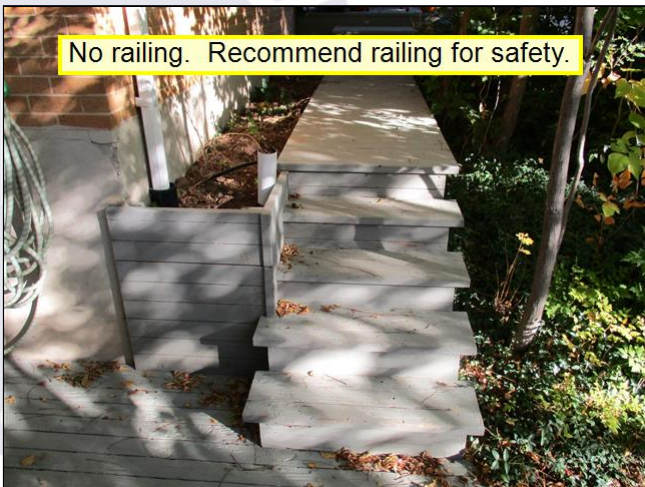
2.3 Item 5(Picture) Front porch

🔧 (2) Areas around porch for animals and insects to enter. This is for your information

Recommend installing railing for safety.

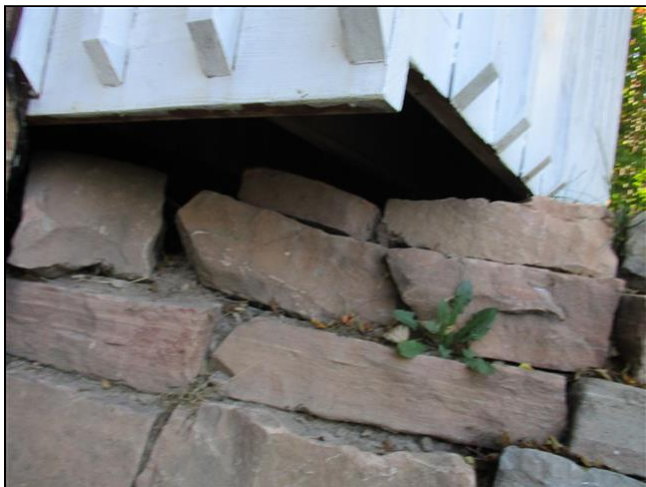
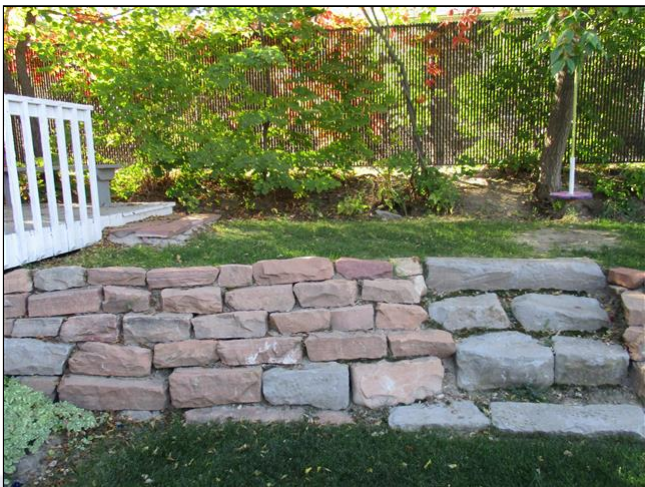
2.3 Item 7(Picture) South side porch

(3) Areas around porch for animals and insects to enter. This is for your information. Area around wall has not railing.

Recommend installing railing for safety.

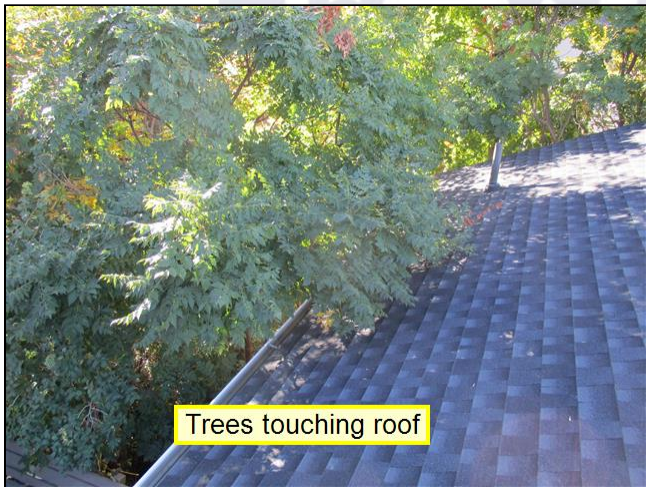
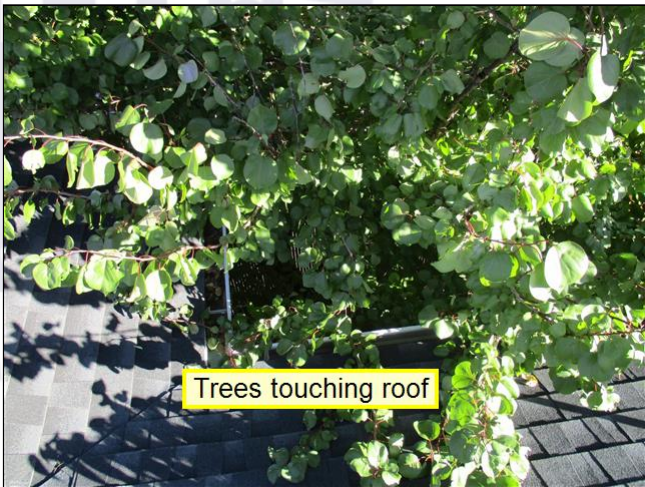
2.4 Item 1(Picture) Trees

(1) -Tree limbs that are in contact with roof.
-Recommend trimming trees from around home.

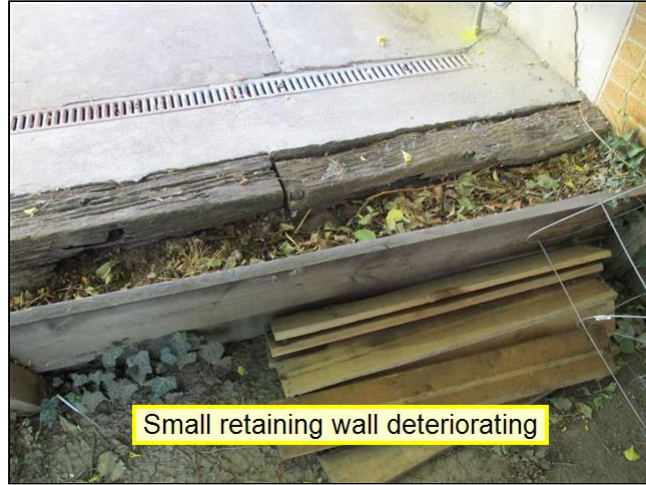
2.4 Item 3(Picture) Retaining wall

🔧 (2) The retaining wall is leaning and erosion signs are present. This problem will continue to become worse and needs correcting.

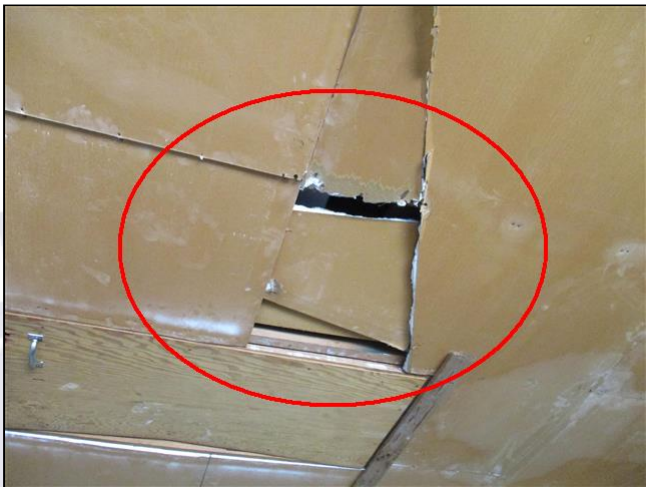
3.0 Item 1(Picture) Garage Ceiling

- Sheetrock on the ceiling is damaged at the garage. This damage is considered cosmetic.
- Recommend repairing as needed.

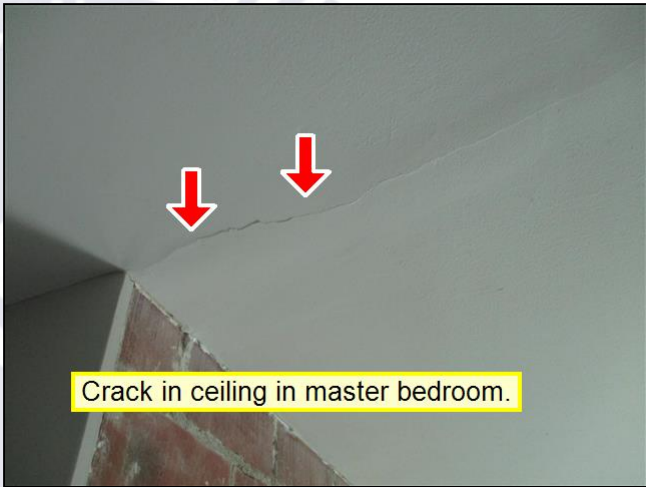
5.0 Item 1(Picture) Master bedroom

- Drywall on the ceiling has several hairline cracks (cosmetic) at the Master Bedroom. While this damage is cosmetic, it needs to be repaired.
- Recommend a qualified person should repair or replace as needed.

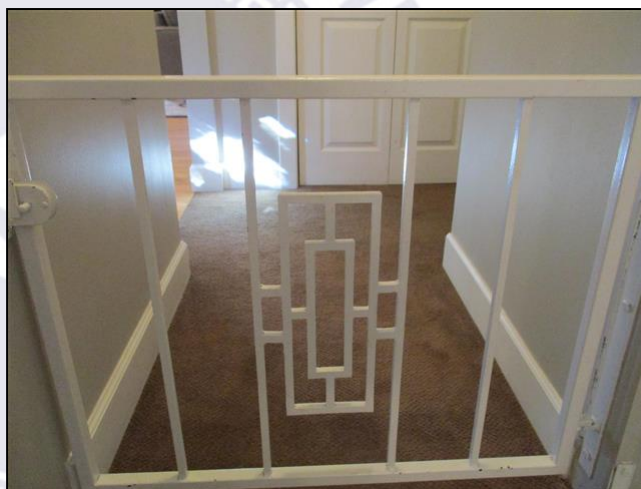
5.3 Item 1(Picture) Down stairs gate

- Downs stairs gate and railing are in good condition. Space between rails appears to be larger than 4 inches and may pose a safety issue. This is for your information.

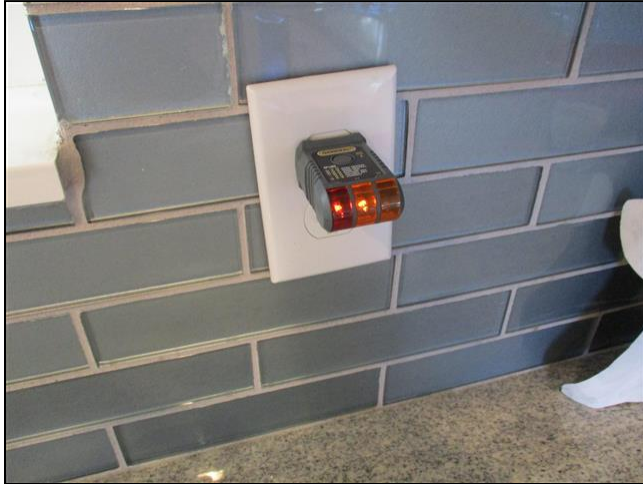
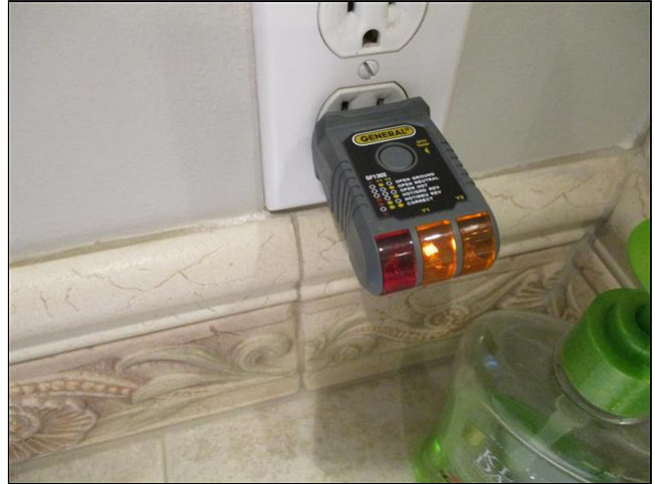
5.6 Item 1(Picture) Wired in reverse

- There are various switches (family room, stair well, entry) that seem to not operate and was unable to find if it connected to switch or outlet. In addition there are some (kitchen, bathroom, TV room) outlets that

have be wired in reverse or have an open ground.
-Recommend having a licensed electrician repair and replace.

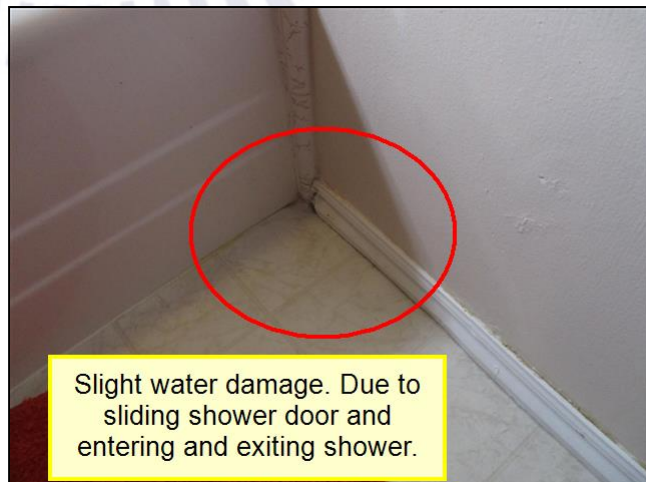
6.7 Item 1(Picture) Downstairs bathroom

- 🔧 -Minor water damage. Due to sliding shower door and entering and exiting shower.
- Recommend repair as needed.

Slight water damage. Due to sliding shower door and entering and exiting shower.

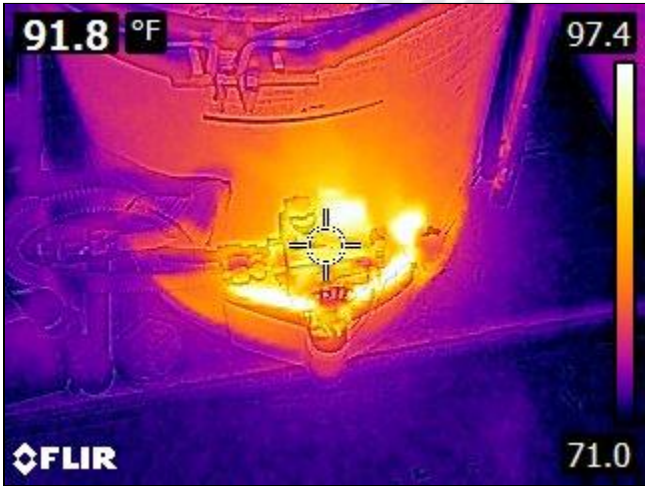
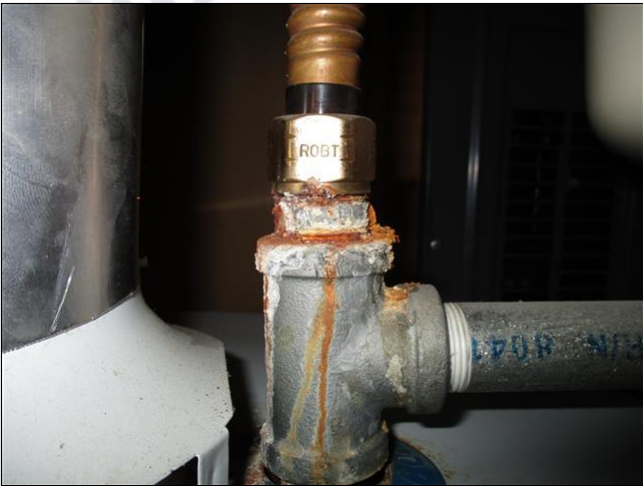
8.1 Item 2(Picture) Corrasion on water heater

-Please see the bathroom and kitchen sections of report.
-Corrasion on water heater due to no dialectic connection
-Recommend repair by a licensed plumber.
-Recommend flushing water heater once a year to prevent sediment from building up.

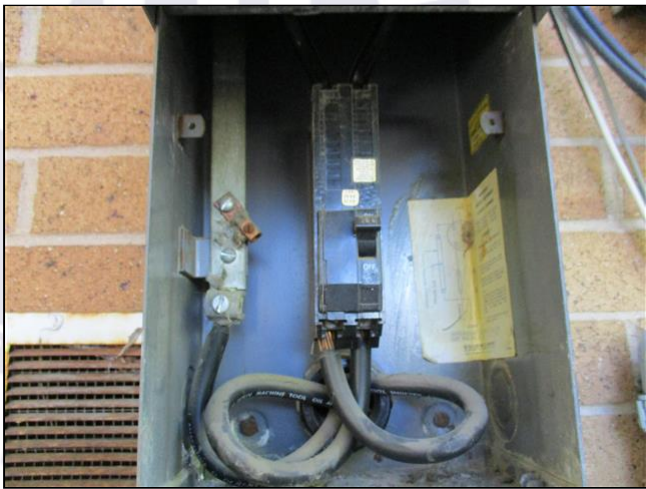
9.1 Item 1(Picture) Main panel

- 100 amp service to home.
- Main electrical panel appeared to be in good condition at time of inspection.
- Distribution panel appeared to be in good condition at time of inspection.
- Cut wires were seen on exterior of distribution panel.
- All wires connections appeared to be secure.
- No overheating, melting or scorching was seen
- No double tapping was seen inside panel.
- Small distribution panel appeared to have low voltage wires inside along with normal connections. This is not recommended.
- AFCI were not tested due to owners occupy home. This is for your information.
- Recommend having a licensed electrician review and advise.

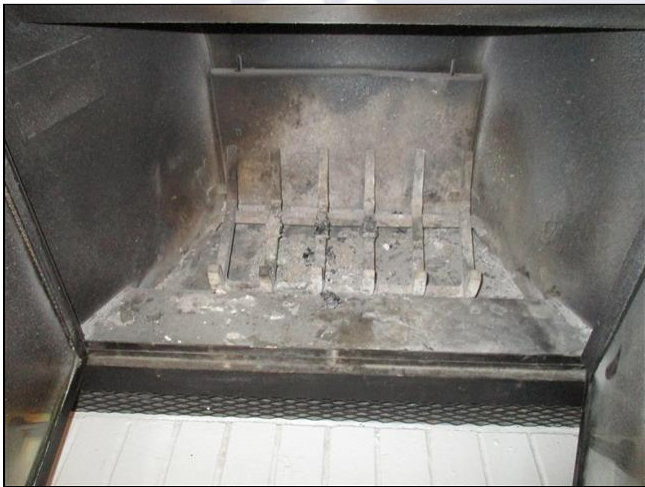
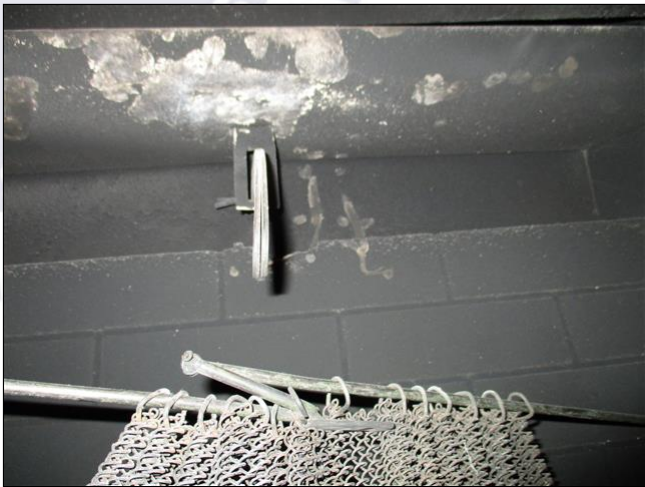
10.6 Item 1(Picture) Upper level fire place

- Fireplace appeared to e in good condition at time of inspection.
- Fireplace damager worked at time of inspection.
- Minor amounts of debris seen inside fireplace at time of inspection.
- Recommend have a licensed professional review and clean before regular use.
